PIC16(L)F18856/18876 Family Silicon Errata and Data Sheet Clarification

The PIC16(L)F18856/18876 family devices that you have received conform functionally to the current Device Data Sheet (DS40001824A), except for the anomalies described in this document.

The errata described in this document will be addressed in future revisions of the PIC16(L)F18856/18876 silicon.

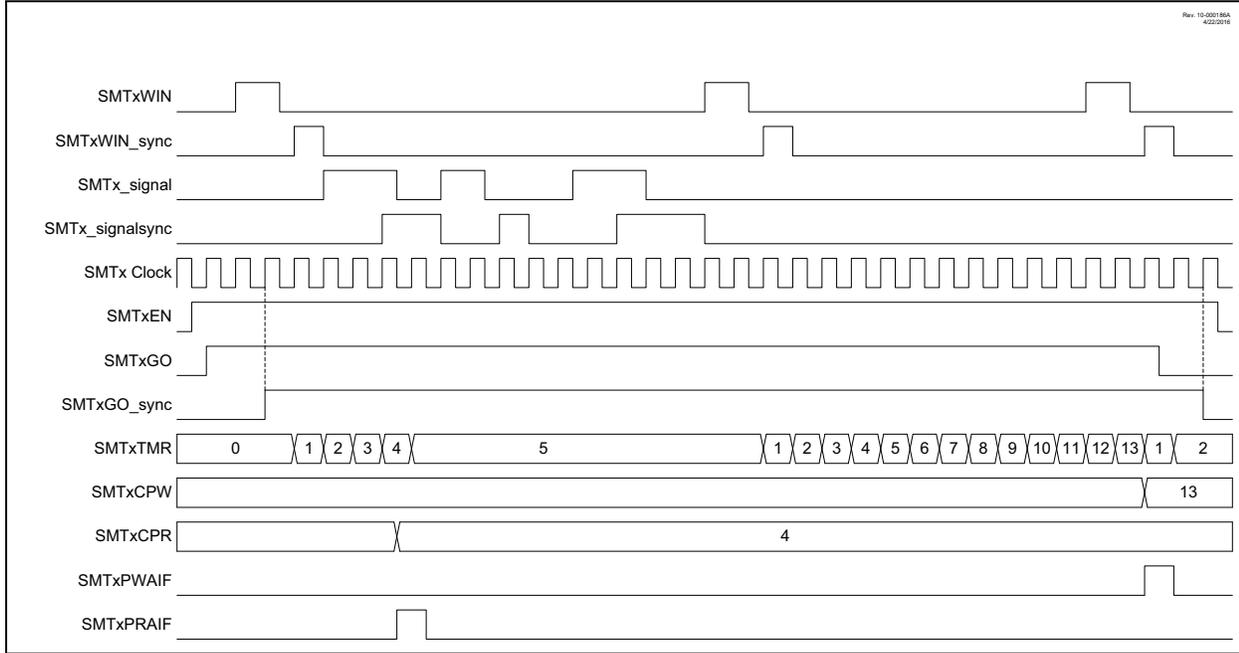
FIGURE 32-14: TIME OF FLIGHT MODE REPEAT ACQUISITION TIMING DIAGRAM

Several timing diagrams in the Signal Measurement Timer chapter (namely Figures 32-14, 32-15, and 32-18) contain inaccuracies. The correct versions of these timing diagrams are below.

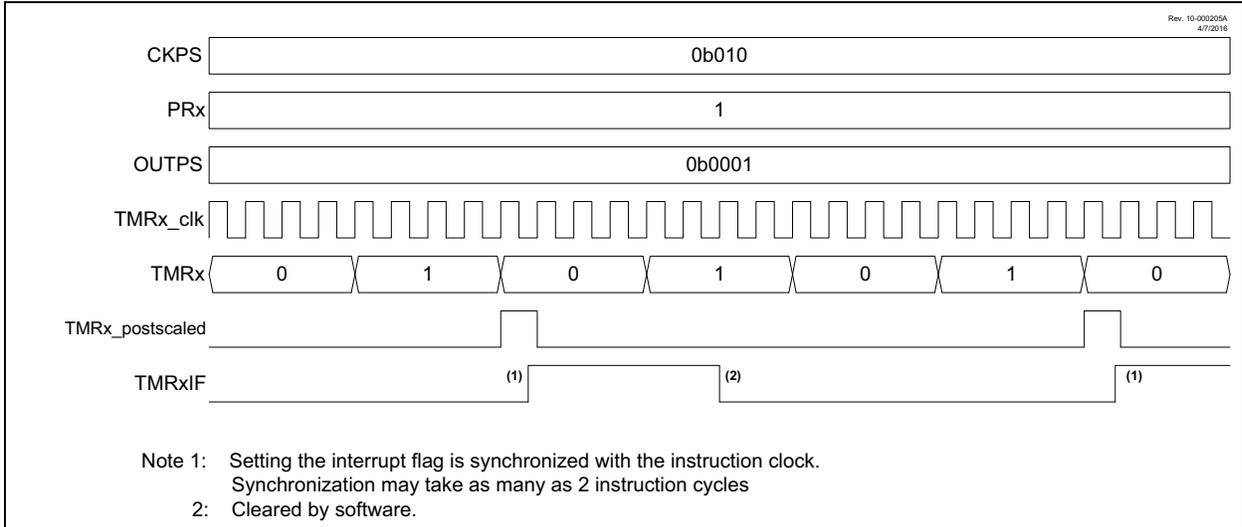
FIGURE 29-3: TIMER2 PRESCALER POSTSCALER, AND INTERRUPT TIMING DIAGRAM

Several timing diagrams in the Timer2/4/6 chapter (namely Figure 29-3, as well as Figures 29-8 through 29-13) contain inaccuracies. The correct timing diagrams are shown below.

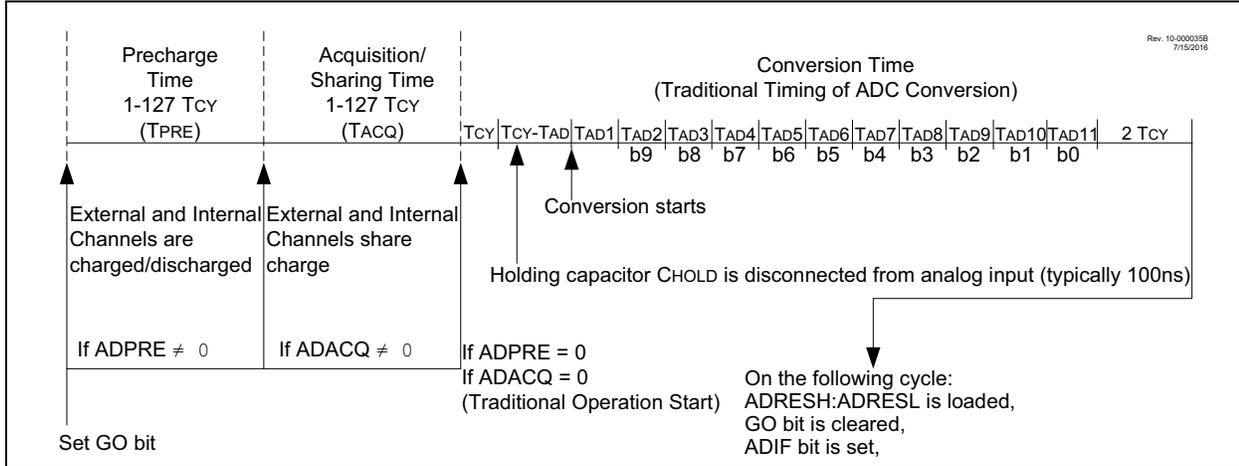
FIGURE 23-2: ANALOG-TO-DIGITAL CONVERTER WITH COMPUTATION (ADC²)

Figure 23-2: Analog-to-Digital Converter with Computation (ADC²) is inaccurately described in the data sheet for the ADCC. It should be as follows:
