dsPIC30F1010/202X Family Silicon Errata and Data Sheet Clarification

The dsPIC30F1010/202X family devices that you have received conform functionally to the current Device Data Sheet (DS70178C), except for the anomalies described in this document.

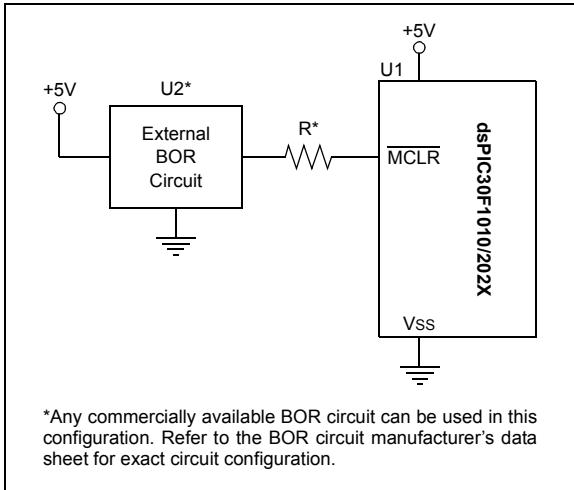
FIGURE 1:

It is recommended that an external Brown-out Reset (BOR) circuit be used to hold the device in Reset, during a brown-out event, to overcome this problem. The external BOR circuit will use the MCLR pin to hold the device in Reset. The following work around, in combination with the external BOR circuit, will ensure that the device is cleanly reset after a brown-out event occurs.

The dsPIC DSC SMPS device must be powered up with the PLL disabled, the Fail-Safe Clock Monitor (FSCM) enabled and clock switching enabled. The PLL should be enabled in software via a clock switch after the device is reset (refer to **Section 29. “Oscillator”** (DS70268) in the “dsPIC30F Family Reference Manual” for details on clock switching). This ensures that the MCLR pin is functional and that the device can be reset by an external BOR circuit (see [Figure 1](#)).
