STM32F101x8/B, STM32F102x8/B and STM32F103x8/B medium-density device limitations

Silicon identification

This errata sheet applies to the revisions B, Z, Y, 1, 2, 3 and X of the STMicroelectronics medium-density STM32F101xx access line and STM32F103xx performance line products, and to revision Y, 1, 2 and X of the STM32F102xx USB access line devices. These families feature an ARM[®] 32-bit Cortex[®]-M3 core, for which an errata notice is also available (see [Section 1](#) for details).

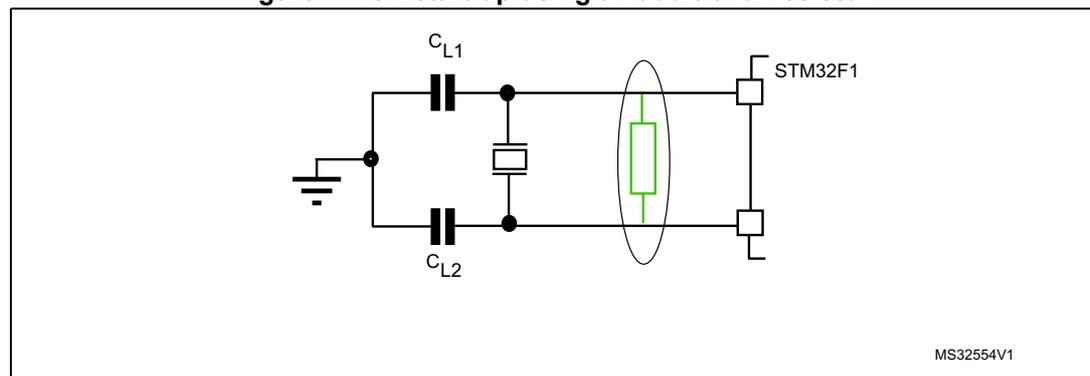
Figure 1. LSE start-up using an additional resistor

The LSE (Low Speed External) oscillator system has been designed to minimize the overall power consumption of the STM32F1 microcontroller. It is extremely important to take specific care in the design of the PCB to ensure this low power oscillator starts in harsh conditions. In some PCB designs without coating, an induced low leakage may prevent the LSE to start-up, regardless of the 32.768 KHz crystal used. This phenomenon is amplified in humid environments that create frost on the OSC32_IN/OSC32_OUT tracks. This unwanted behavior may happen only at the first back-up domain power-on of the device.

It is recommended to mount an additional parallel feedback resistor (from 16 M Ω to 22 M Ω) on board to help the oscillation start-up in all cases (see [Figure 1](#)). For more details on compatible crystals and hardware techniques on PCB, refer to AN2867 application note.
